# **A Long Term Study on the Performance of Early Streamer Emission Air Terminals in a High Keraunic Region**

Z. A. Hartono and I. Robiah

*Lightning Research Pte. Ltd.*

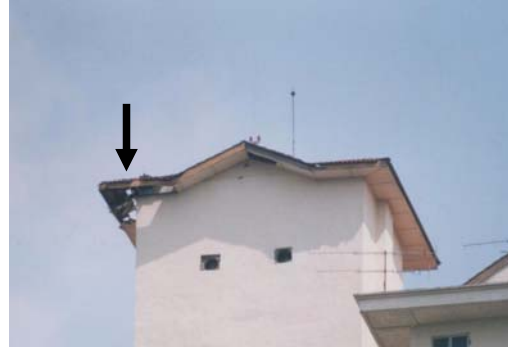
Figure 6: A photograph of the other Setapak Ria apartment building showing a different French made ESE air terminal and the stricken point.

A recent survey shows that the buildings had been struck several times by lightning. A close inspection shows that some of the stricken points had occurred on the same roof where the air terminals were located (Figures 5 and 6).

In these cases, the stricken points had come to within 10m of the air terminals that were installed at the center of the roof.

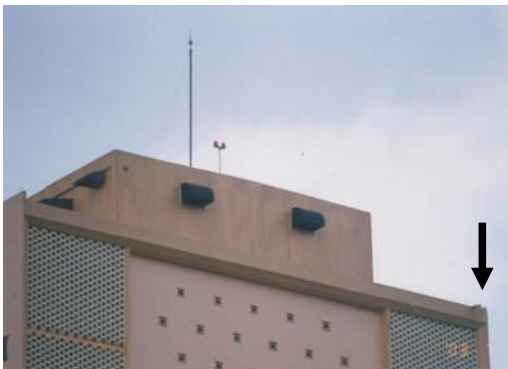
In 2003, the building was observed to have been struck by lightning on the corner of the building that was about 10m away and about 8m below the air terminal (Figure 4).

Figure 4: A photograph of the Wisma Tanah building taken in 2003. The building had been struck by lightning as can be seen on the right.

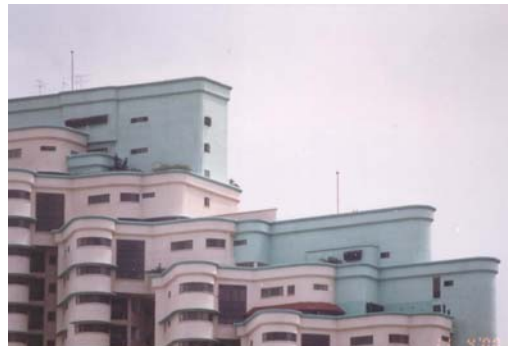
These 170m high split-level conjoined buildings were installed with the Australian made ESE air terminals mounted on 5m poles. One air terminal was installed per apartment building and they were centrally located on the roof (Figure 7).

Figure 7: Photograph of the Villa Putri apartment building showing the two Australian made ESE air terminals installed on the split-level roofs.

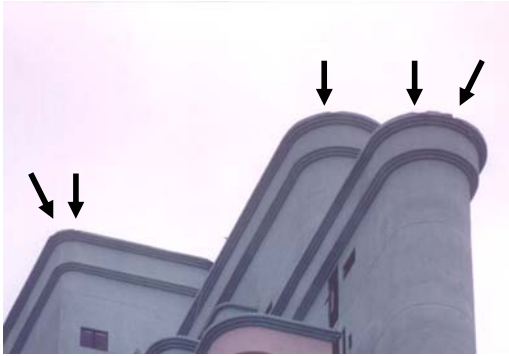
Figure 8: A close-up photograph of the apartment showing some of the multiple stricken points that have accumulated in the five year period since the building was installed with the ESE air terminals.

However, within a five year period, it was observed that seven stricken points had occurred on the rounded edges of the upper, middle and lower roofs. These stricken points clearly show that the enhanced protection claimed by the manufacturer was non-existent (Figure 8).

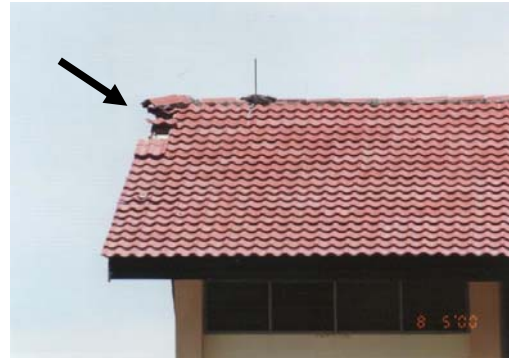
These buildings have been installed with the conventional system but the Franklin air terminals and conductors were not positioned at the known high risk locations i.e. at the ridge ends and edges of the gable roof.

As expected, the stricken points occurred at the predicted locations (Figures 9 and 10). The failure of

the Franklin rods to intercept the lightning stroke has more to do with erroneous positions of the rods rather than the rods themselves.

Figure 9: Photograph of a stricken point at the gable roof ridge end. The Franklin rod should have been installed right on top of the ridge end instead of about 1m away from it.

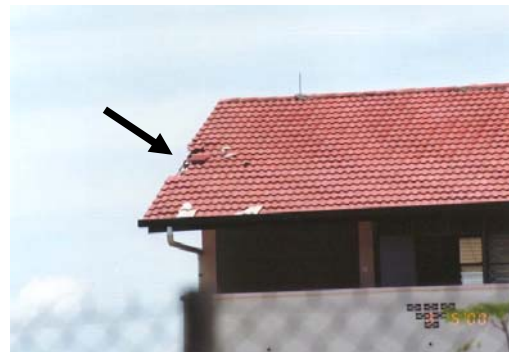
Figure 10: Photograph of a stricken point on the slanting edge of the gable roof. The air terminal conductor should also be installed on the edges of the gable roof.

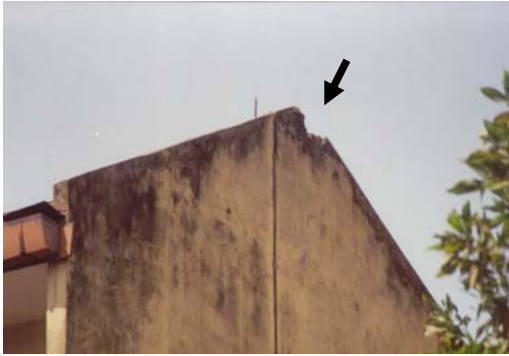
Similar to the school buildings mentioned above, the Franklin rods were not positioned at the known high risk locations. Since these buildings have been built more than a decade ago, many of the apartment blocks had been struck by lightning at almost the exact same location i.e. at the ridge ends of the gable roof. In some cases, adjacent blocks of apartment display similar stricken points (Figures 11 and 12).

Figure 12: A close-up photograph of another apartment block showing the stricken point and the Franklin rod beside it. For effective protection, the rod must be positioned right on the ridge ends and similar high risk locations.

These damages could have been prevented if the Franklin rods had been installed right on top of the ridge ends. In this way, the recommendations mentioned in the draft Australian/New Zealand standard represent a significant step towards a more effective application of the conventional air terminal and should be seriously considered.
