## 29<sup>th</sup> International Conference on Lightning Protection

### PERFORMANCE OF NON-STANDARD LIGHTNING AIR TERMINALS: REVISITED

Z. A. Hartono  
Lightning Research plc  
zahartono@ieee.org  
457 Jalan B11, Taman Melawati, 53100 Kuala Lumpur, Malaysia

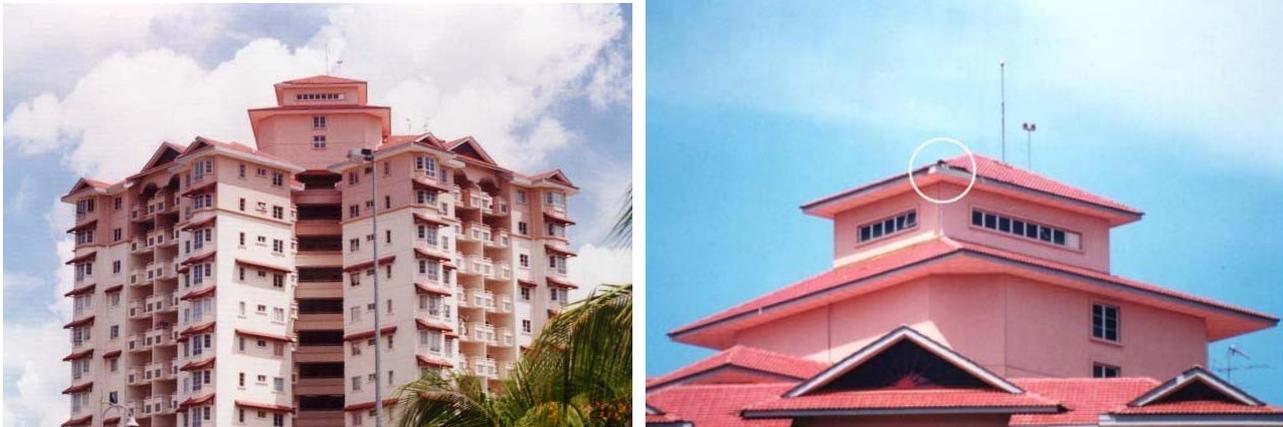
Since observations began nearly two decades ago, a growing number of bypasses have been observed on some of these roofs that were installed with air terminals that complied with either the NF C 17-102 [15] standard (Fig. 1), i.e.

the ESE manufacturing and installation standard published by the French ESE manufacturers, or the CVM (Fig. 2). The occurrences of bypasses were recorded on many structures protected by early streamer emission (ESE) or collection volume method (CVM) air terminals. These suggest that the NF C 17-102 standard and the collection volume method of air terminal placement are defective. Therefore, the ESE/CVM air terminals are not better than the Franklin rods.

Fig. 1 – A bypass occurred close to an ESE air terminal that is manufactured and positioned according to the NFC 17-102 standard.

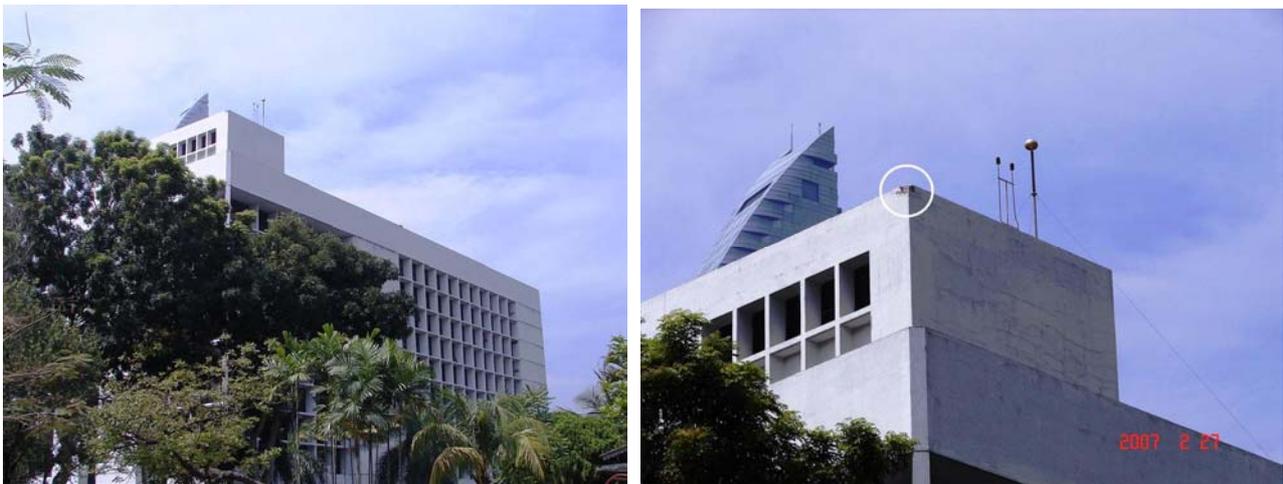
Fig. 2 – A bypass occurred close to a CVM air terminal that is positioned according to the proprietary collection volume method.

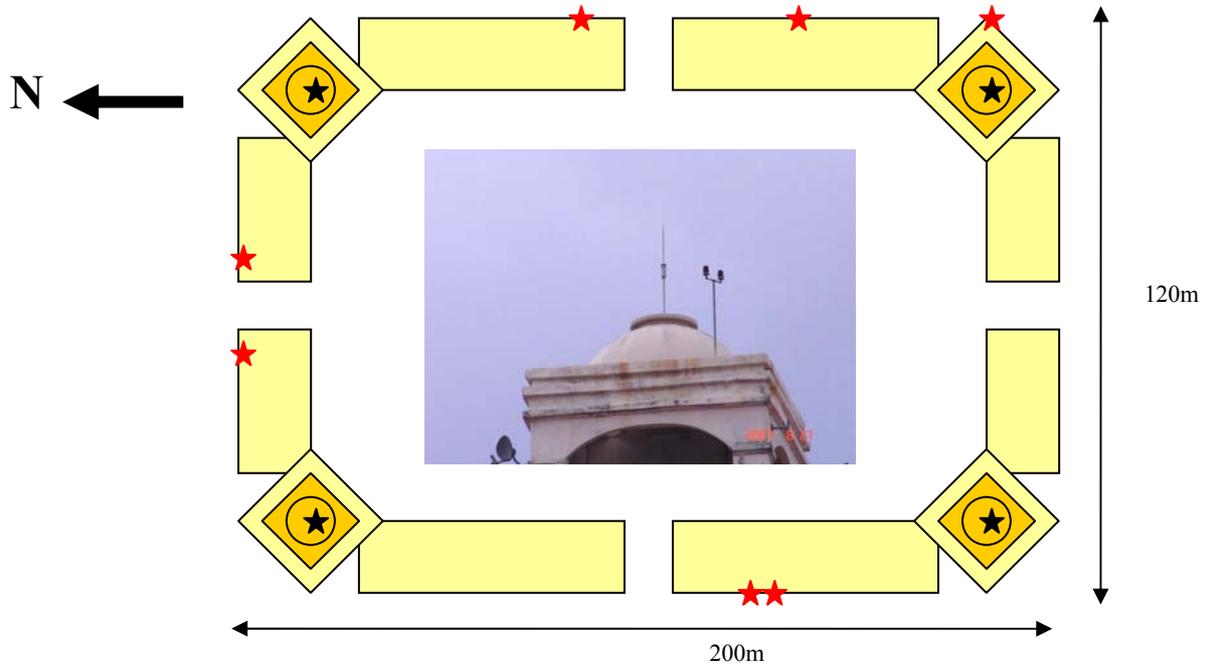
Since the apartment blocks were completed in 2004, seven bypasses have been observed (Fig. 3). Six of the bypasses occurred on the facades and corners in between two adjacent ESE air terminals while one bypass occurred on the corner of a tower block a few meters away from an air terminal.

This case study suggests that the use of multiple ESE air terminals to protect a large building have not prevented the occurrence of bypasses due to lightning. The study also suggests that the repositioning of the ESE air terminals towards the corners of the building have resulted in fewer occurrences of bypasses at these locations. This result is expected

Fig. 3 – A plan view of the Crimson Apartments. The black five-pointed stars indicate the positions of the ESE air terminals on the tower block while the red stars indicate the positions of the observed bypasses. The picture in the centre of the diagram shows one of the observation decks with an ESE air terminal installed on it.

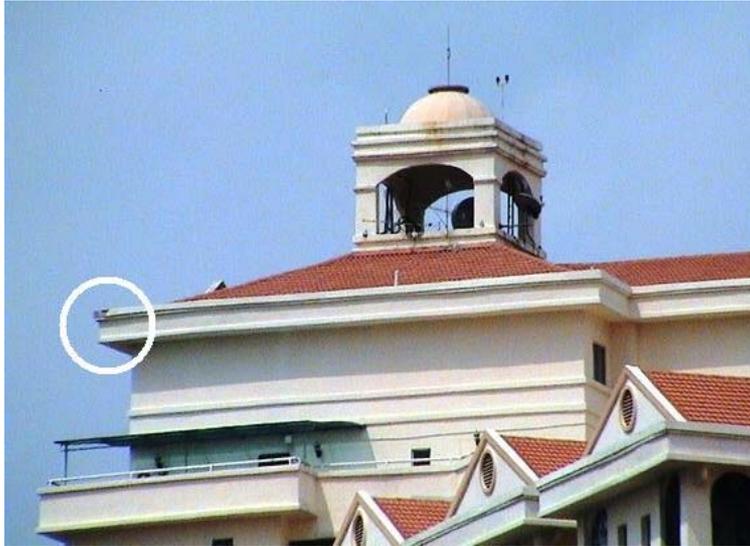
Fig. 5 – The bypass that occurred at the corner of the South-East tower block. This bypass is similar to that shown in Figs. 1 and 2.

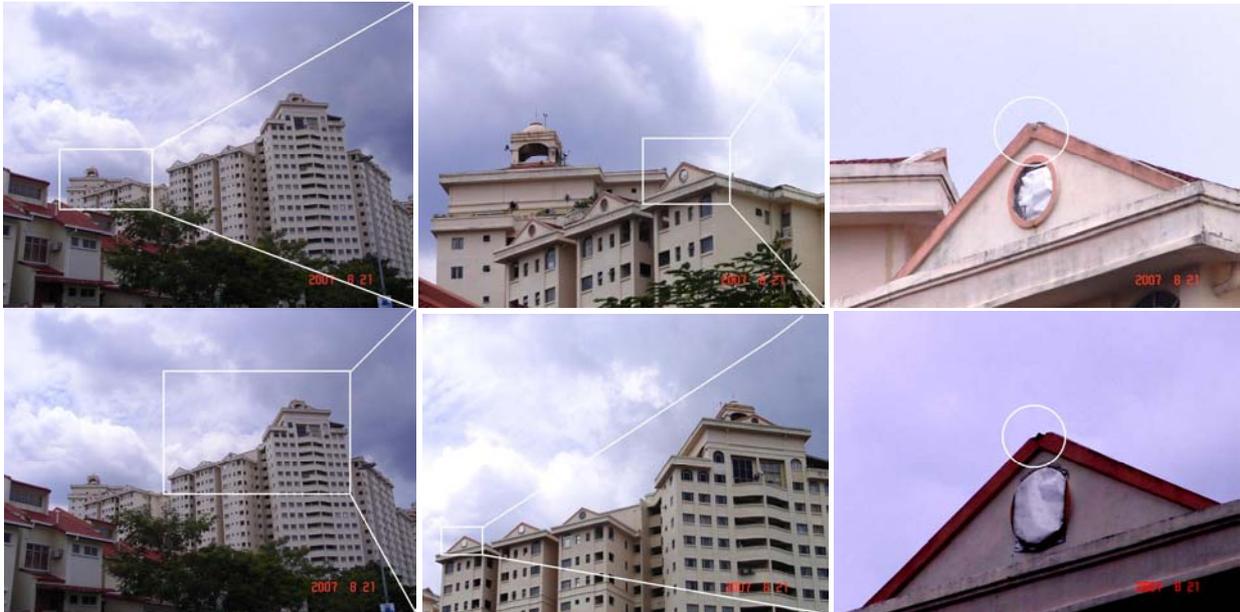
Fig. 6 – The two bypasses that occurred at the northern side of the Crimson Apartments.

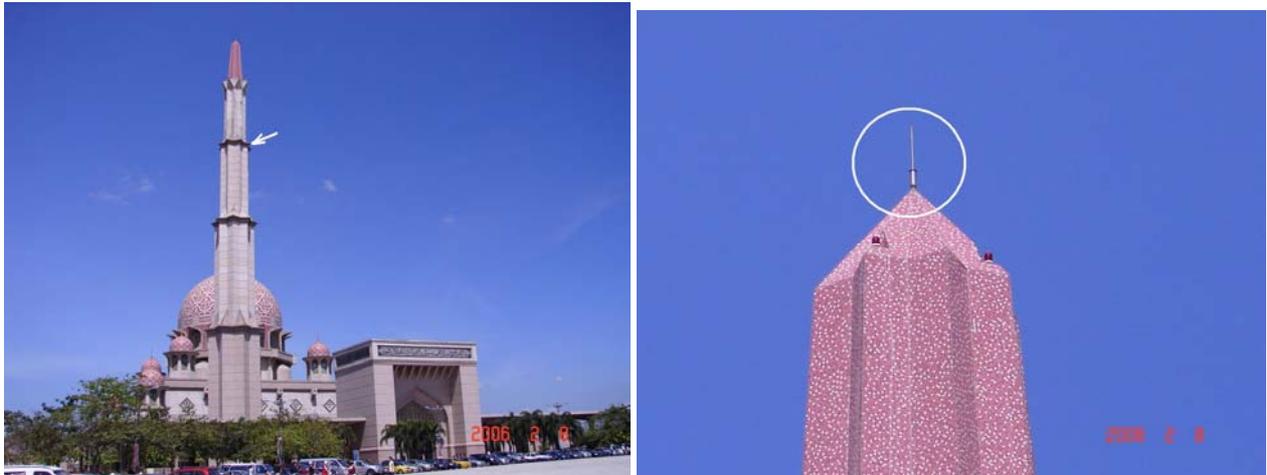
The minaret was struck by lightning and a bypass was observed on a protruding marble structure on the parapet wall of the minaret about 30 meters below the air terminal. Since the minaret has a radius of about 5m at the bypass location,

it is well within the air terminal's protection radius according to the NF C 17-102 standard. This suggests that the NF C 17-102 standard is defective even for applications to very slim structures such as a minaret.

Fig. 7 – The picture on the left shows the Putrajaya mosque and the position of the bypass (arrowed). The picture on the right is a close-up photo of the apex of the minaret and shows the ESE air terminal.

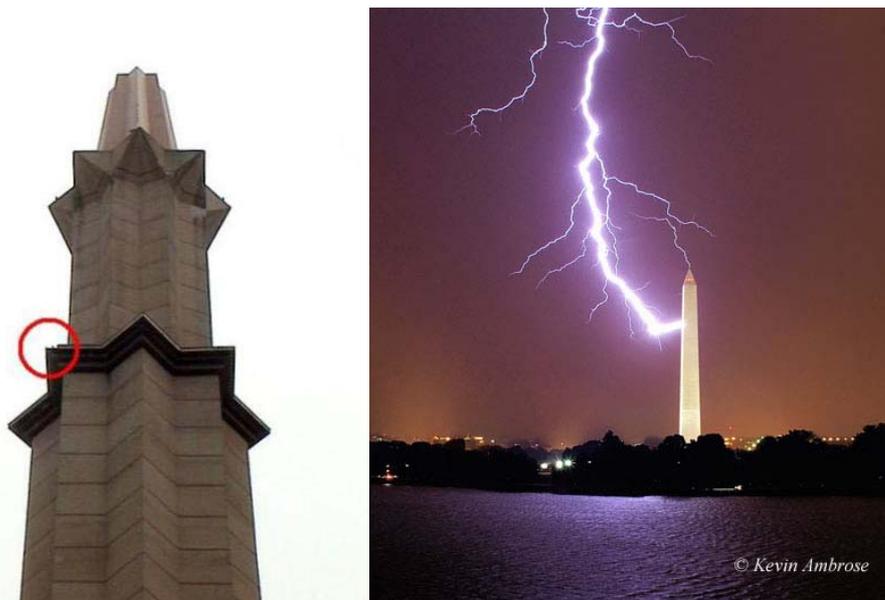
Fig. 8 – The photo on the left shows the location of the bypass on the minaret. The photo of the Washington Monument on the right shows how lightning might have struck the side of the Putrajaya minaret (Courtesy: Kevin Ambrose)

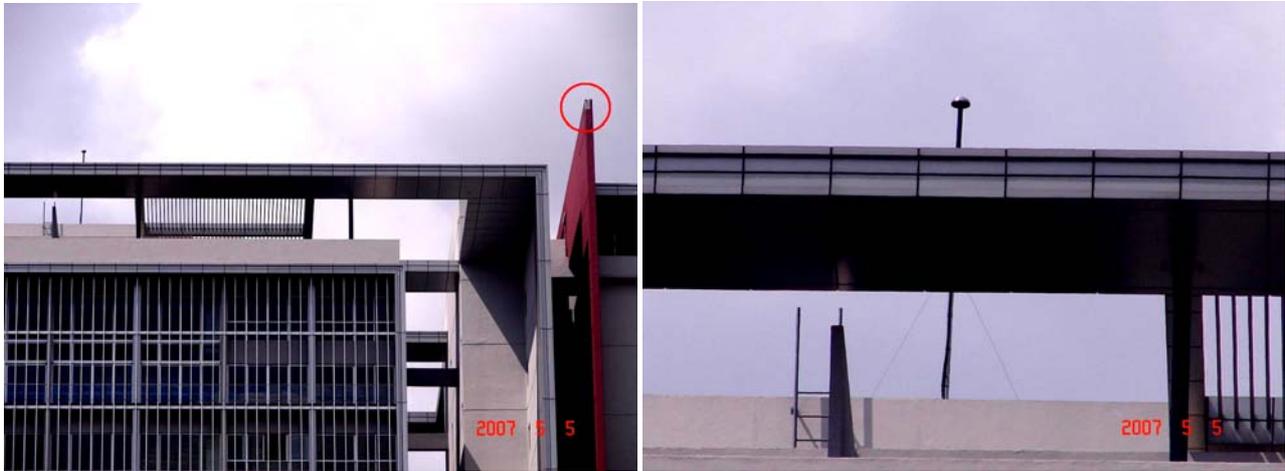
The claimed enhanced protection radius is doubtful since a bypass has been observed about 30m away from the new

CVM air terminal which was installed on the Dua Residency, a new residential high rise building in downtown Kuala Lumpur (Fig. 9). This bypass suggests that the new CVM air terminal is no better than the previous one at protecting buildings from lightning strikes and that the collection volume method is flawed. Incidentally, the bypass had occurred within six months of the new air terminal installation.

Fig. 9 – The bypass that occurred on the Dua Residency condominium (left). The new ESE air terminal (right) is positioned on the roof near the centre of the building about 30m away from where the bypass occurred.

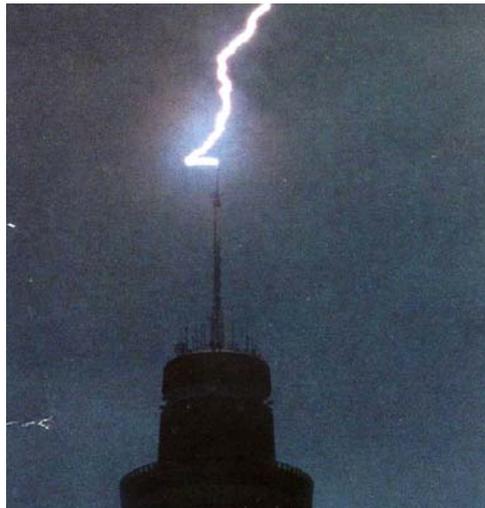
The first photograph (Fig. 11) showed a lightning flash intercepted by an ESE air terminal that was positioned according to the CVM. Mousa pointed out that the presence of a horizontal component of the return stroke attached to the ESE air terminal suggested that there was no early streamer formation. Had there been an early streamer formation, the initial return stroke path would have been in the upward direction and not horizontal as shown.

Fig. 11 – A photograph of the return stroke attached to a CVM air terminal (Courtesy: Global Lightning Technologies/Erico).

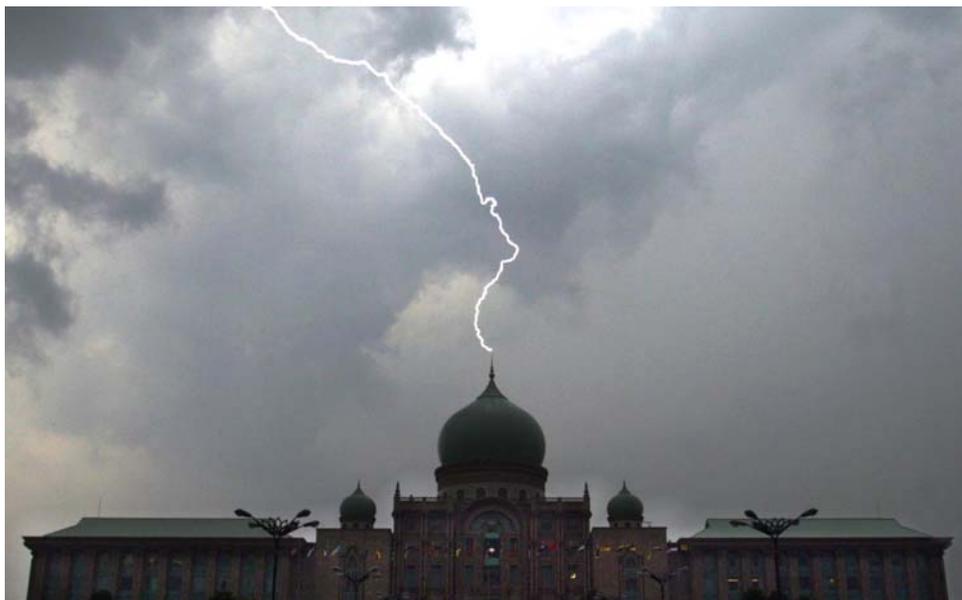
The second photograph (Fig. 12) showed a lightning return stroke intercepted by an ESE air terminal installed according to the NF C 17-102 standard. Similar to the previous photograph, there was no evidence to show that an early streamer formation had taken place from the air terminal since the initial return stroke emanating from the terminal was not in the direction of the downward leader and was non-linear.

Fig. 12 - A photograph of the return stroke attached to an ESE air terminal (Courtesy: The Star Publications, Malaysia).

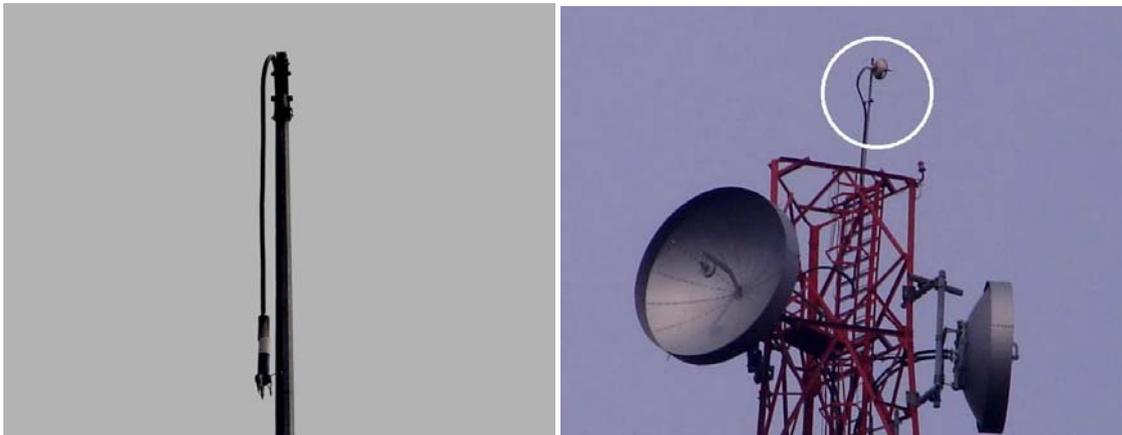
It has been observed that some of the mounting poles of the ESE/CVM air terminals, which were made from either fiberglass or fiber reinforced plastic, have been damaged as a result of lightning strikes. This suggests that the coaxial down conductors did not fully contain the current from the lightning flash.

Fig. 13 – Photographs showing the ESE (left) and CVM (right) air terminals hanging by their down conductors as a result of damages to their non-metallic mounting poles.
