## 29<sup>th</sup> International Conference on Lightning Protection

### PERFORMANCE OF NON-STANDARD LIGHTNING AIR TERMINALS: REVISITED

Z. A. Hartono  
Lightning Research plc  
zahartono@ieee.org  
457 Jalan B11, Taman Melawati, 53100 Kuala Lumpur, Malaysia

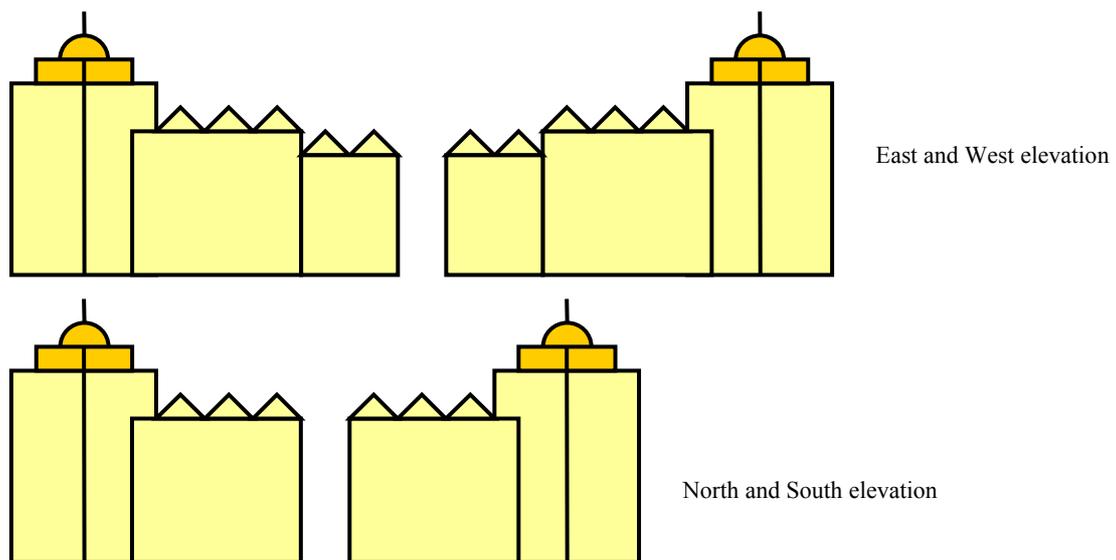
Since the apartment blocks were completed in 2004, seven bypasses have been observed (Fig. 3). Six of the bypasses occurred on the facades and corners in between two adjacent ESE air terminals while one bypass occurred on the corner of a tower block a few meters away from an air terminal.

Fig. 4 – Elevation diagrams of the Crimson Apartments.

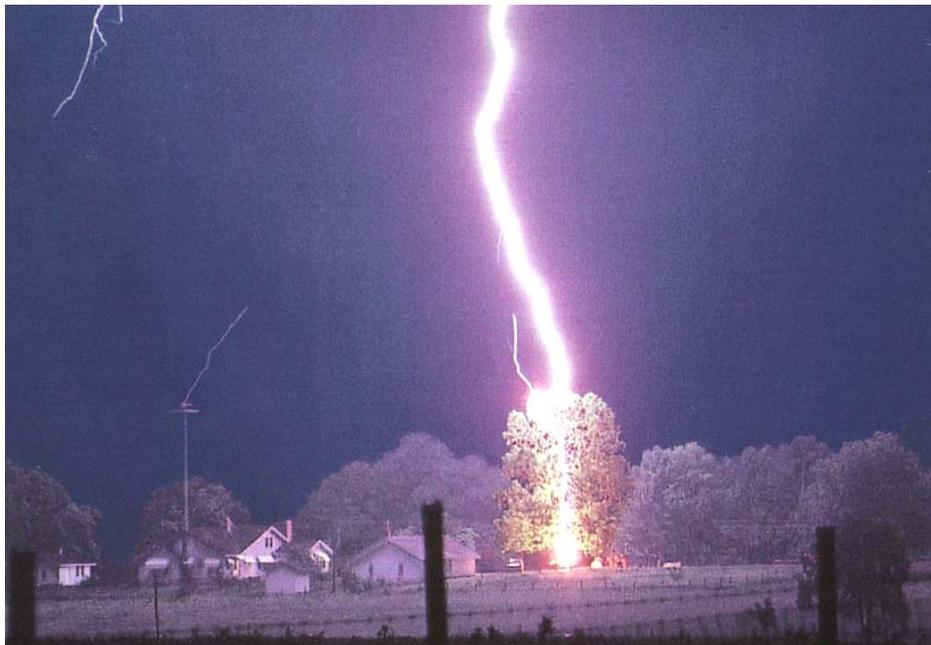
Fig. 10 – A photograph showing streamers emitted in the upward direction by grounded objects. (Courtesy: National Geographic)
